Revised (3) April 2019

Dealer Service Instructions for:

Safety Recall V06 / NHTSA 19V-021 Drag Link

The drag link on about 795,000 of the above vehicles may have been built with an outboard steering linkage jam nut that could loosen allowing one end of the drag link to separate from the adjuster sleeve. A drag link separation can result in a loss of directional steering control, which can cause a vehicle crash without prior warning.

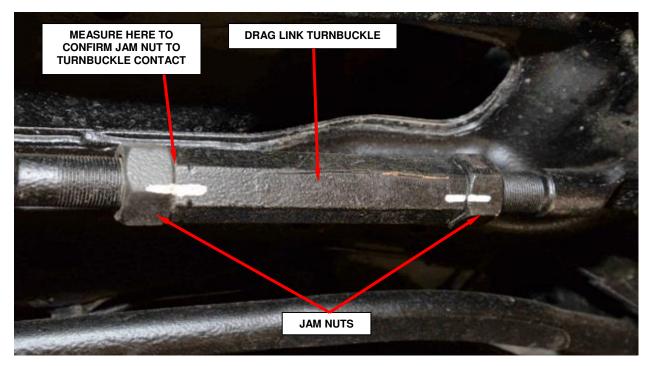
Figure 1 - Mark Jam Nuts and Turnbuckle

- 1. Inspect the drag link assembly for drag link to turnbuckle separation.
 - ➤ If no separation is observed, continue to Step 2.
 - ➤ If the vehicle was towed in and separation has occurred, continue to section **D. Replace Drag Link Assembly.**
- 2. Using a .020" feeler gauge, confirm jam nut contact to drag link turnbuckle. If no contact is noted, proceed to section **B. Measure Drag Link Assembly Threads** (Figure 1). **Jam nut to turnbuckle gap is not considered separation.**
- 3. Using a paint pen or equivalent, mark both jam nuts and turnbuckle with lines (Figure 1).
- 4. Hold the drag link turnbuckle with back-up wrench (Figure 2).
- 5. Using a 41 mm crowsfoot, such as Special Tool 2069400190 (Snap-on SCOM41) or equivalent, set a torque wrench to 20 N·m (15 ft. lbs.) (Figure 2).

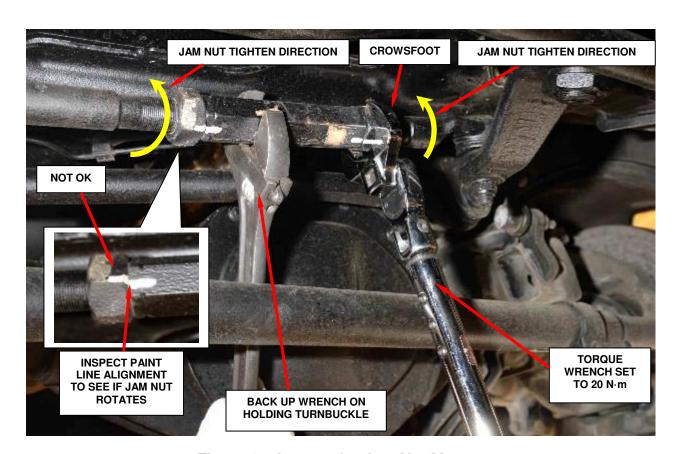
Figure 2 – Inspect for Jam Nut Movement

- 6. Rotate each jam nut **in direction as shown** (tightening direction) until wrench clicks or 20 N·m (15 ft. lbs.) is achieved (Figure 2).
 - ➤ If paint lines do not show nut rotation, continue to section C. Weld Turnbuckle Jam Nuts.
 - ➤ If either paint line <u>shows</u> nut rotation, continue to section <u>B. Measure</u> **Drag Link Assembly Threads.**

- 10. Using a backer wrench and a 41 mm crowsfoot, such as Special Tool 2069400190 (Snap-on SCOM41) or equivalent, set a torque wrench to 105 N⋅m (77 ft. lbs.) and attempt to loosen each jam nut (ref: Figure 2 for set-up).
 - ➤ If both jam nuts **do not** rotate (breakaway), continue to step 11.
 - ➤ If <u>either jam nut rotates</u> (breakaway), <u>repeat Steps 5 through 10 on a different turnbuckle flat.</u>
- 11. Paint the area to prevent rust using MS-PF-1-25 black paint or equivalent.
- 12. Remove the supports and lower the vehicle.
- 13. Connect the negative battery cable and return the vehicle to the customer.

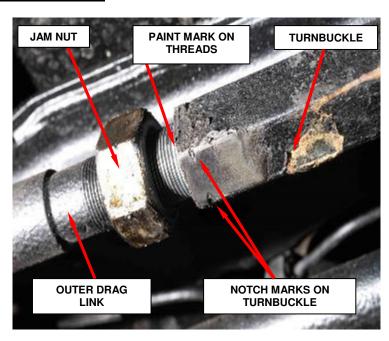
Figure 3 - Paint Mark on Threads

- 1. Back off both jam nuts enough to paint mark threads.
- 2. Paint mark threads of outer drag link at turnbuckle (Figure 3).
 - NOTE: Turnbuckle end with notch marks on hex goes toward the outer drag link.
- 3. Remove the turnbuckle from the inner and outer drag links (Figure 4).

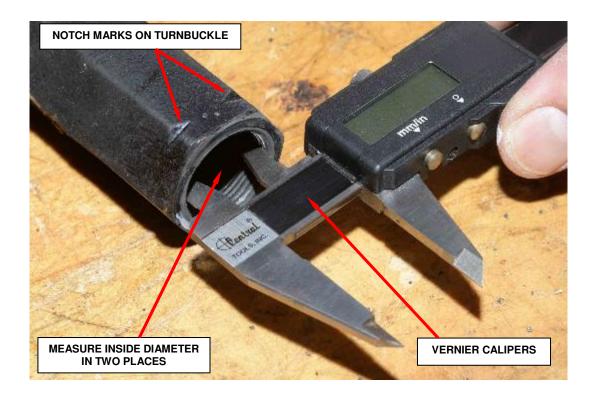
Figure 5 – Measure Inside Diameter of Turnbuckle at Notched End

4. Using Vernier Calipers, measure and record the inside diameter of the turnbuckle (end with notch marks on hex) (Figure 5).

NOTE: Measure the inside diameter at two different locations (90° from each other). Use the largest measurement.

- ➤ If the result of the subtraction is 0.6 mm (0.024 in) or less, continue to section **D. Replace Drag Link Assembly.**
- ➤ If the result of the subtraction is greater than 0.6 mm (0.024 in), assemble the turnbuckle and continue to section <u>C. Weld Turnbuckle Jam Nuts.</u>

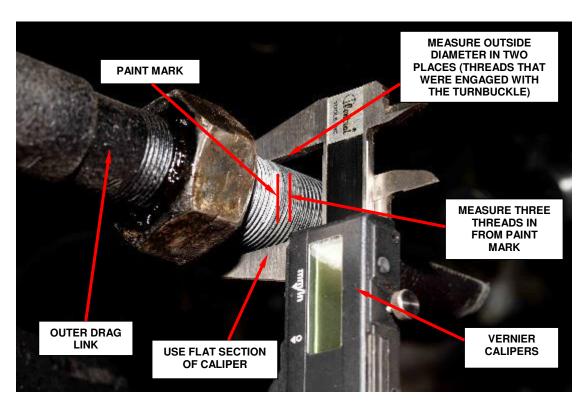
Figure 6 - Measure Outside Diameter of Outer Drag Link

5. Using Vernier Calipers, measure and record the major outside diameter of the outer drag link threads 5mm (0.20 in. - approx 3 threads) from paint mark denoting end of turnbuckle (Figure 6). Be sure to measure using the flats on the calipers, do not measure inside the thread pitch (Figure 6).

NOTE: Measure the outside diameter at two different locations (90° from each other). Use the smallest measurement.

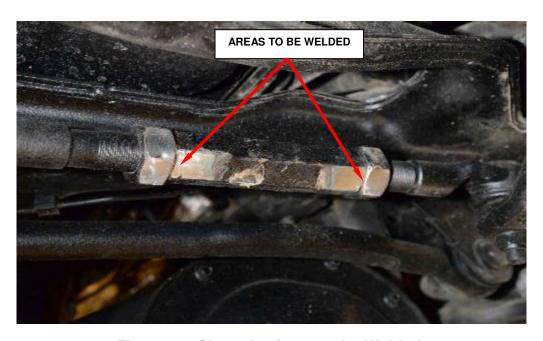
Figure 7 - Clean the Areas to be Welded

- Comply with all federal, state and local regulations to avoid any injuries due to shock, fires, fumes, sparks and liquids.
- All flammable materials or liquid should be stored in tightly sealed and labeled containers, and used only in well ventilated areas.
- No spark producing equipment should be permitted in any area where flammable materials are being handled or stored.
- 5. Clean the areas to be welded. Areas must be free of dirt, oil, water, salt, undercoating, moisture or any other contaminant that would affect the weld, then wire brush the area (Figure 7).

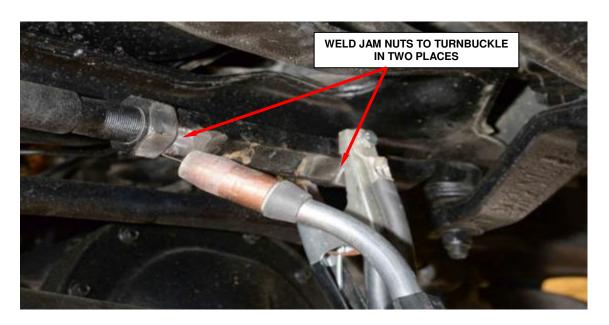
Figure 9 - Weld Both Jam Nuts to the Turnbuckle

7. Using a Lincoln Powerwave 350 Flux Cored Arc Weld (MIG) or equivalent GMAW (MIG) welding machine (140-150 amps), apply a **17mm long weld the length of one turnbuckle flat on each jam nut** (Figure 9).

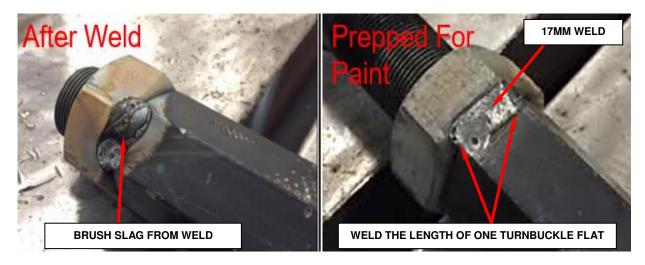
Figure 10 - Prepare areas for Paint

- 8. Wire brush the slag from the surface of the welds (Figure 10).
- 9. Allow to cool to room temperature.

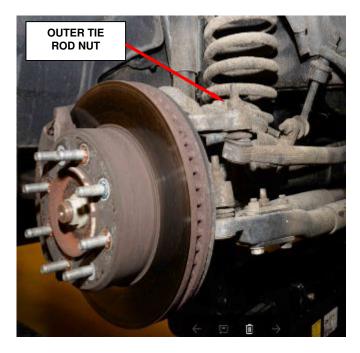
Figure 11 – Outer Tie Rod

- 1. Raise and support the vehicle.
- 2. Remove the right front tire and wheel assembly.
- 3. Remove and **DISCARD** the outer drag link to tie rod nut (Figure 11).
- 4. Remove the outer drag link tie rod from the knuckle using C-3894-A (puller shown in Figure 12).

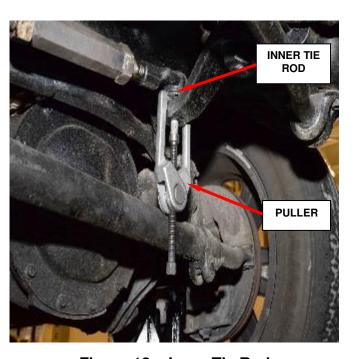
Figure 12 – Inner Tie Rod

- 5. Remove and **DISCARD** the inner drag link to pitman arm nut (Figure 12).
- 6. Remove the inner tie rod end from the pitman arm using special tool C-3894-A (Figure 12).
- 7. Remove and **RETURN** the drag link assembly. See Parts Return section.

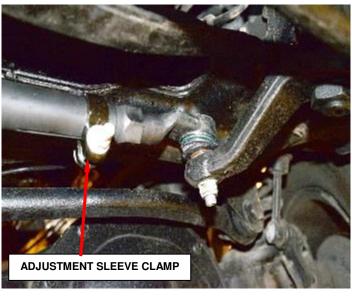
Figure 14 - Adjustment Sleeve Clamp

- 12. Remove the supports and lower the vehicle.
- 13. Adjust the toe and center the steering wheel.
- 14. After adjustment tighten tie rod adjustment sleeve clamp bolt to the 75 N·m (55 ft. lbs.) (Figure 14).
- 15. Return the vehicle to the customer.
